OPERATION PLUMBBOB

Project 30.6

TEST OF FRENCH UNDERGROUND
PERSONNEL SHELTERS

TEST OF FRENCH UNDERGROUND PERSONNEL SHELTERS

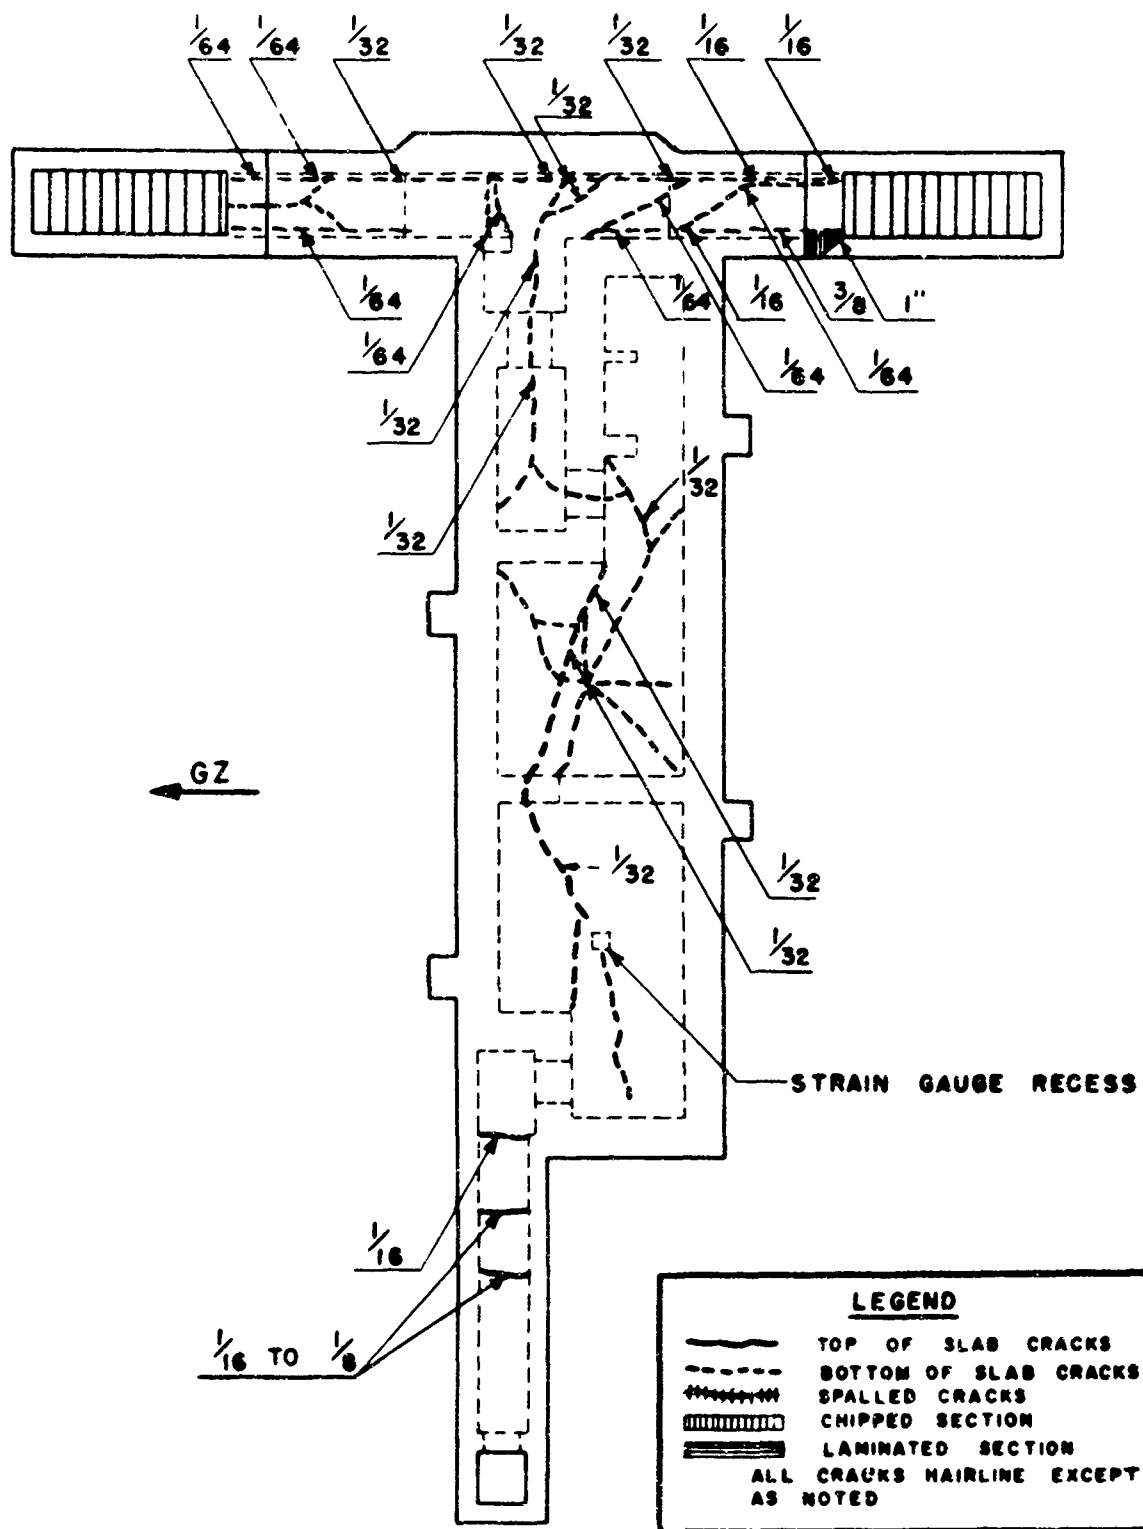
Fig. 3.1—Roof-slab crack pattern, structure II-1.

(a) *Entranceways.* In the entrance facing GZ a $\frac{1}{64}$ -in. crack occurred along the intersection of the roof slab and the interior wall. At the intersection of the exterior wall and the slab, the separation varies from $\frac{1}{64}$ in. at the top to $\frac{1}{32}$ in. at the bottom of the sloped portion of the slab. One hairline crack starts at the top of the roof slab and runs along the center line for about two-thirds of the sloped portion of the slab, at which point the crack branches off into two sections, one section leading to each wall. The stairs are separated from the interior wall by a crack that varies from hairline in size at the sixth riser from the top to $\frac{1}{16}$ in. at the bottom tread. The exterior wall is separated from the stairs by a similar crack, except that its size at the bottom tread is $\frac{1}{32}$ in. One hairline crack in the exterior wall is located at the eleventh riser from the top.

(b) *Antechamber.* One $\frac{1}{32}$ -in. crack was formed in the roof slab of the antechamber, beginning directly over the center of the gastight door and continuing across three-quarters of the length of the room, at which point it flaired diagonally to the exterior and interior walls. This crack appears to be a continuation of the transverse crack in the roof slab of the entrance. The branch of the crack that leads toward the interior wall terminates at a point directly over the center line of the secondary blast door. This crack is also visible in the lower section of the lintel beam above the secondary blast and gastight doors.

(c) *Main Chamber.* The section of the main chamber adjacent to the secondary gastight door has minor structural damage. The crack that is present in the antechamber is continued into this section. It intersects a $\frac{1}{32}$ -in. crack that starts at the interior corner of the small partition behind the gastight door and runs into the forward room of the main chamber. The floor, roof, and walls of the ventilation chamber were not damaged.

The forward room of the structure has a $\frac{1}{32}$ -in. crack in the roof slab leading from the interior corner of the antechamber to a point near the top of the center of the lintel beam over the opening in the main-chamber partition. The crack is also present in the lintel beam. Diagonal hairline cracks start at the center of the roof slab and run toward the corners of the slab. The walls of the forward room are not damaged. The floor slab has a $\frac{1}{64}$ -in. crack that starts at a point located at the front of the ventilating room and runs to the center of the room where a box-shaped crack has been formed around the survey point X-13. It then continues to the center of the opening in the main partition.

In the rear room of the main chamber, the $\frac{1}{32}$ -in. crack in the roof slab of the forward room continues past the lintel beam and ends at a strain-gauge recess located in the center of the roof slab. Hairline cracks lead from the recess and run toward the rear walls of the structure. The $\frac{1}{64}$ -in. crack in the floor slab of the forward room continues past the opening toward the center of the room. This crack intersects another $\frac{1}{64}$ -in. crack that begins at a concrete deformer gauge mount and runs toward the rear of the structure. There is a $\frac{1}{64}$ -in.-wide crack that connects the two concrete deformer mounts near the front of the rear room.

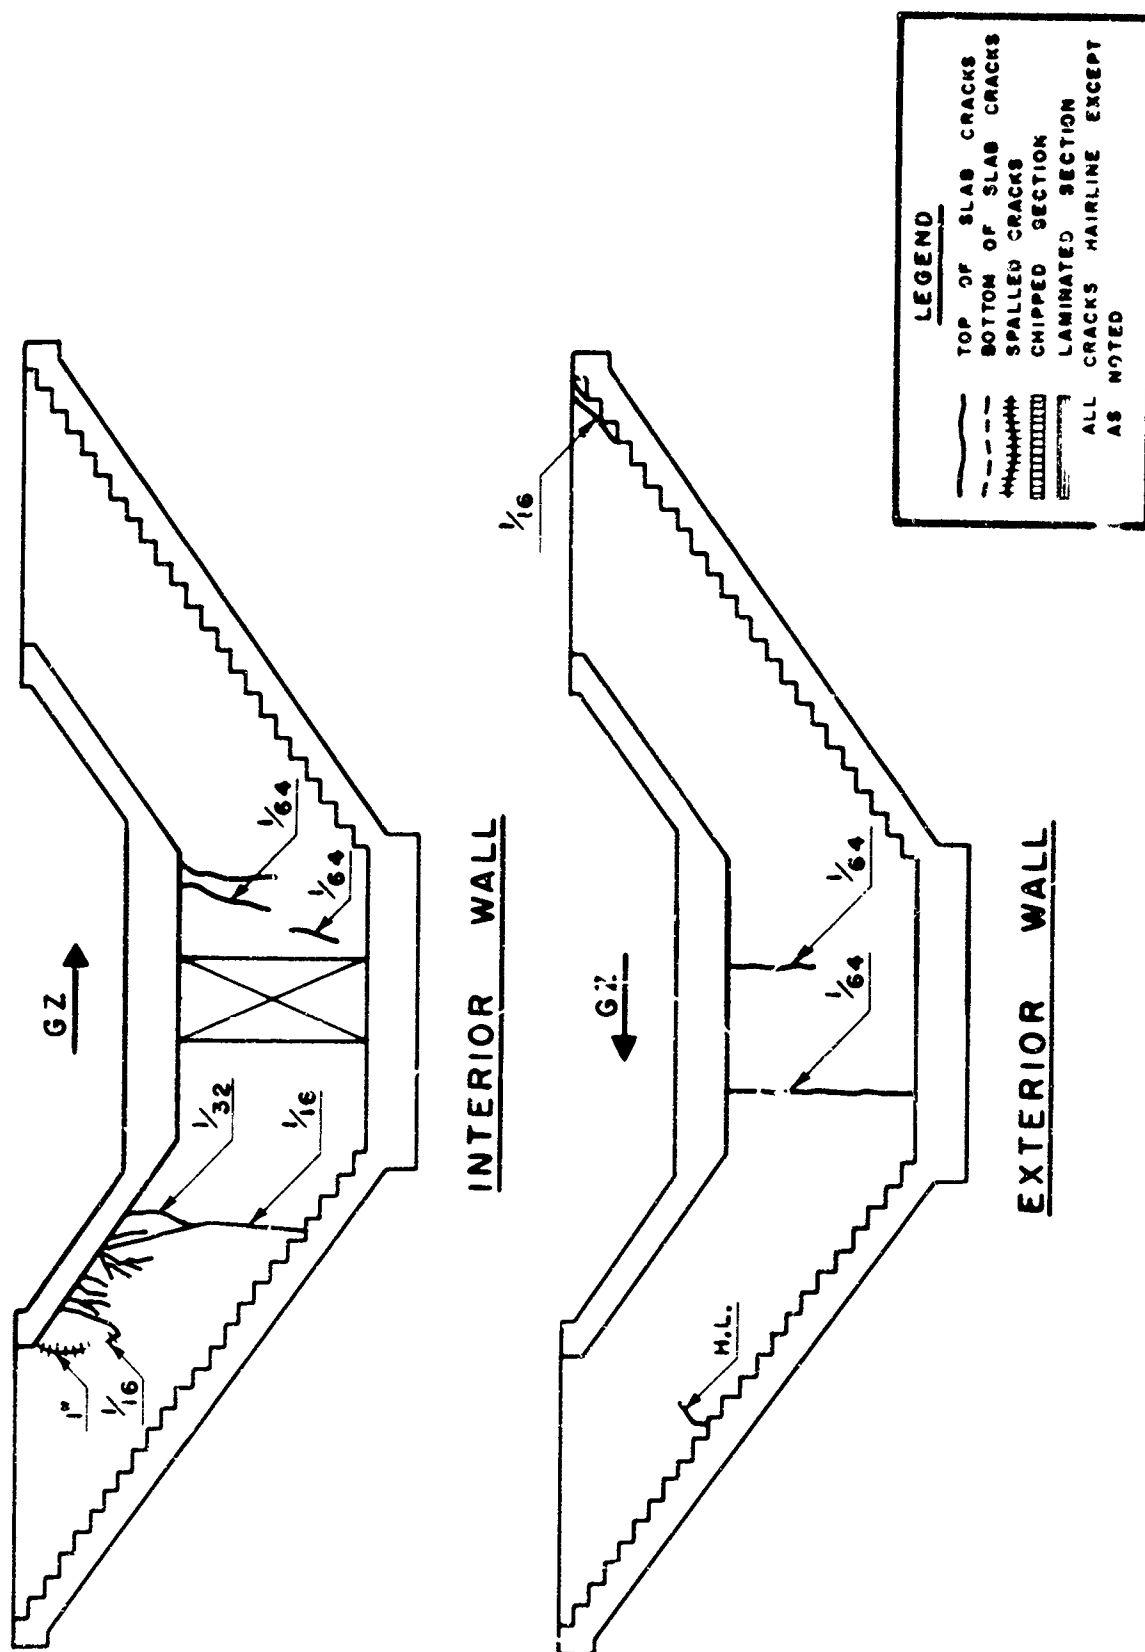
Fig. 3.3—Entrance crack pattern, structure II-1.

The landing roof slab has a $\frac{1}{32}$ -in. crack along its intersection with the exterior wall. A $\frac{1}{32}$ -in. transverse crack was observed to start at a point directly over the center of the blast door and continue out to a point located along the center-line of the landing; at this point the crack divides into two $\frac{1}{32}$ -in. cracks, which continue across the slab to the exterior wall. At the corner of the opening in the interior wall, a diagonal crack starts and runs to the exterior wall near the sloped portion of the roof slab over the entrance away from GZ. Two $\frac{1}{64}$ -in. transverse cracks are located at the GZ side of this opening. These cracks run the width of the landing. The interior wall has several vertical $\frac{1}{64}$ -in. cracks located on the GZ side of the door opening. Two vertical $\frac{1}{64}$ -in. cracks were observed in the exterior wall above the landing.

At the intersection of the roof slab and both walls on the side away from GZ, cracks were found varying in size from $\frac{1}{32}$ to $\frac{1}{16}$ and $\frac{1}{16}$ to 1 in. in width for the exterior and interior walls, respectively. There is a diagonal $\frac{1}{64}$ -in. separation starting at the bottom of the sloped portion of the roof near the interior wall and continuing to the top of the slab at the exterior wall. The intersection of the interior wall and the stairs has a crack that is $\frac{1}{16}$ -in. in width near the lower tread, increasing to $\frac{3}{8}$ in. at the seventh riser from the top, and decreasing again to $\frac{1}{8}$ in. near the top of the stairs. The crack along the exterior wall and the stairs is $\frac{1}{8}$ in. for three-quarters the height of the stairs; it decreases to $\frac{1}{16}$ in. at the second riser from the top. The interior wall of this entrance has a crack that starts at the intersection of the top of the roof slab and the wall and runs vertically downward toward the stairs. This crack is 1 in. in size at the roof and $\frac{1}{16}$ in. at its terminal point located approximately at the mid-height of the wall. Spalling is evident along the entire length of the crack. A $\frac{1}{16}$ -in. vertical crack was formed above the fourth tread from the bottom; it runs the full height of the wall. Several vertical hairline cracks are located near the roof slab. The exterior wall has a $\frac{1}{16}$ -in. crack located near the top four risers of the stairs.

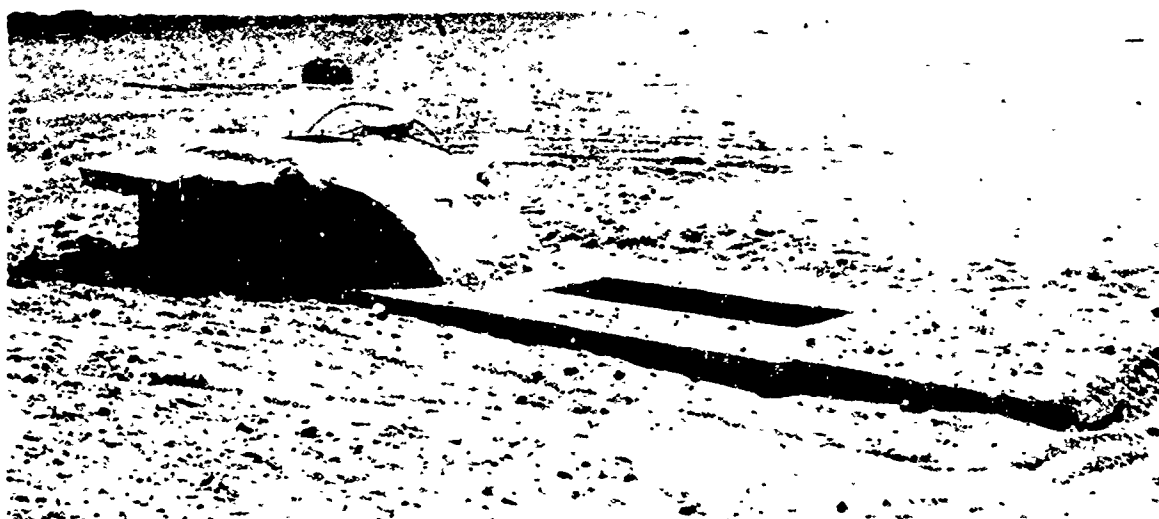
Fig. 3.44 — Detail view of blast damage to main entrance and sand-pit.
